Sloan® Flushometer

PARTS LIST

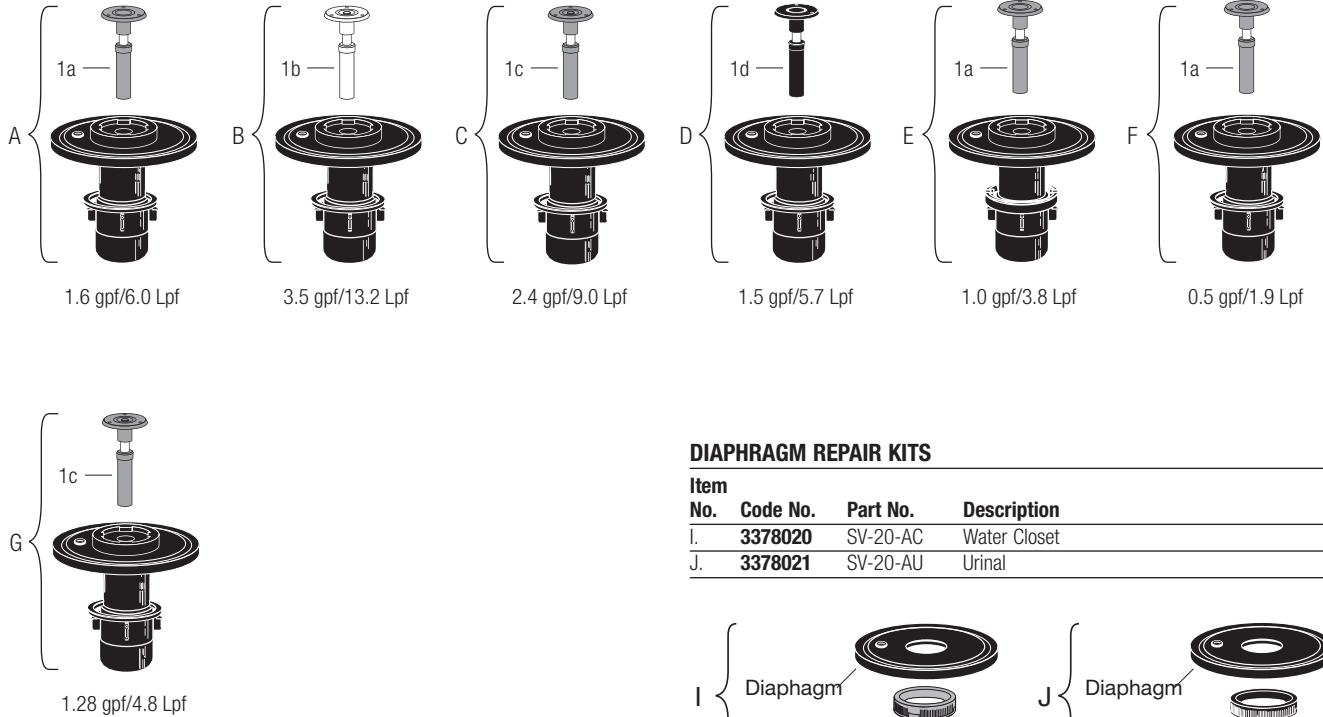
INSIDE COMPONENTS

Item No.	Code No.	Part No.	Description
1a.	5301211	A-19-ALC	Relief Valve, Green (Closet/Urinal-LC) – 12 per package
1b.	5301058	A-19-AC	Relief Valve, White (Closet) – 12 per package
1c.	0301143	A-19-AL	Relief Valve, Blue (9 Liter Closet)
1d.	5301059	A-19-AU	Relief Valve, Black (Urinal) – 12 per package

Item No.	Code No.	Part No.	Description
I.	3378020	SV-20-AC	Water Closet
J.	3378021	SV-20-AU	Urinal
