FQE80U FilterQuick™ easyTouch[®] **Electric Fryer**

Service Manual

Part Number: FRY_SM_8197953 01/2024

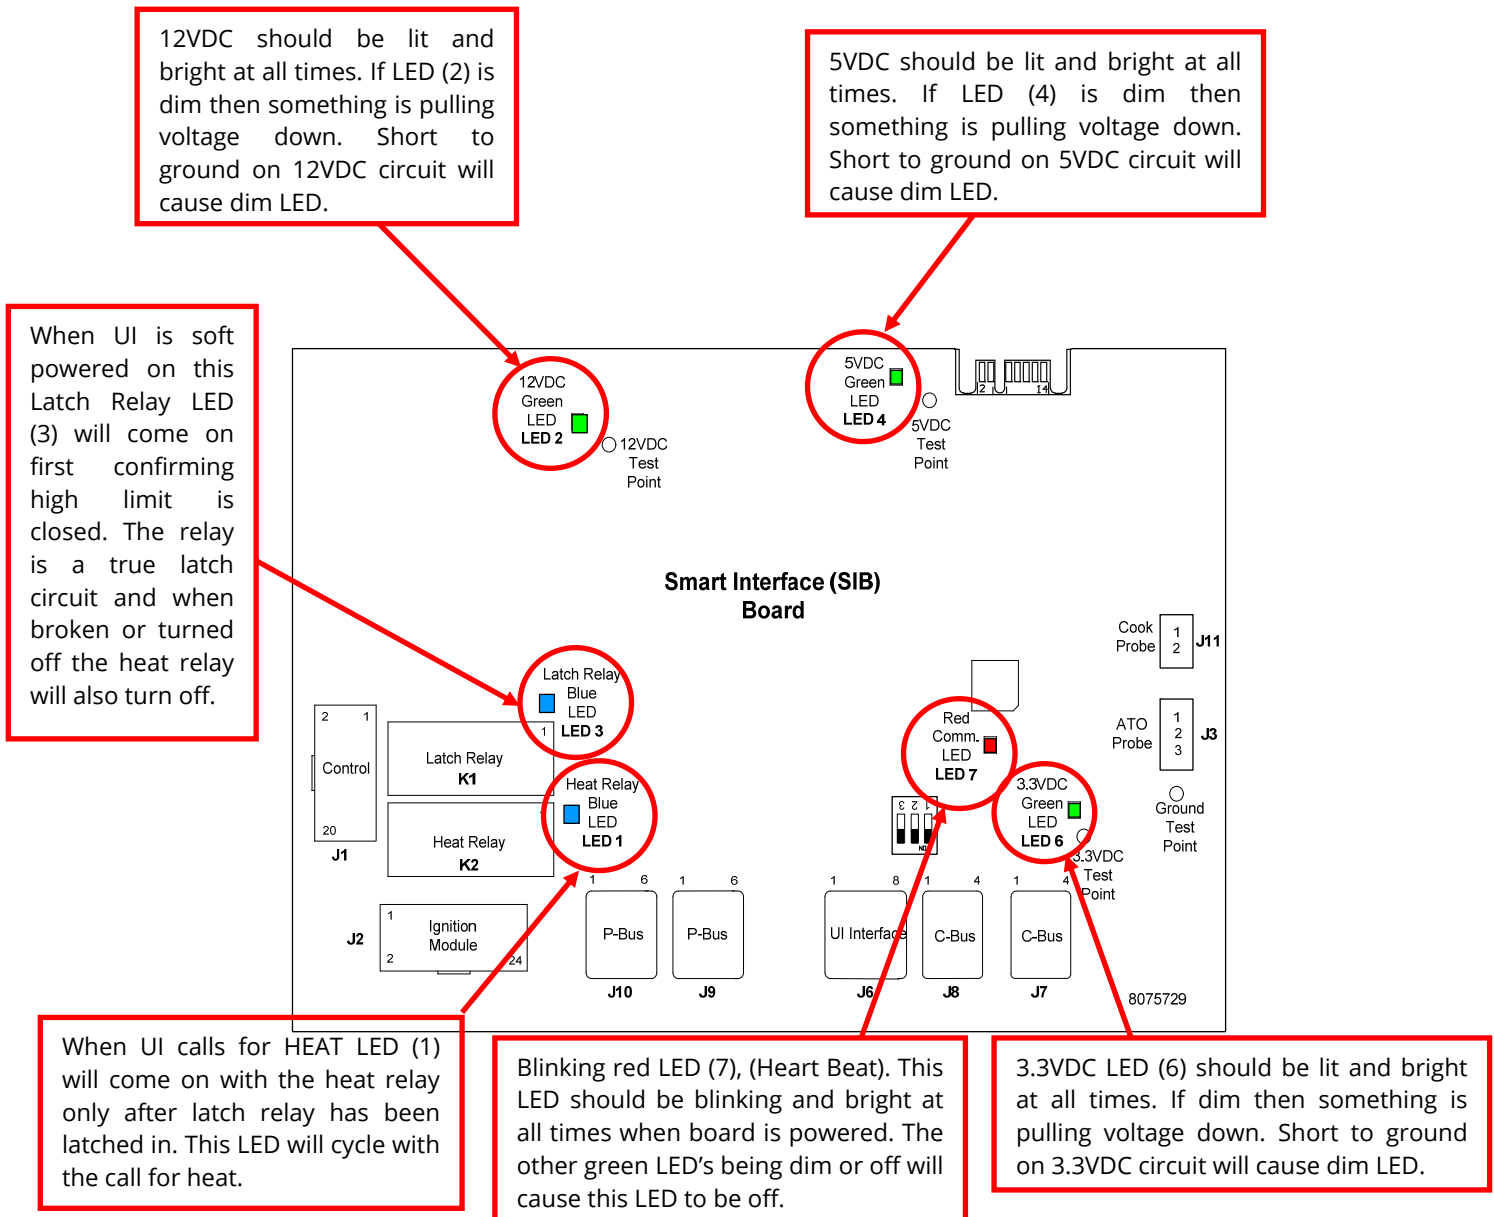
K2 is a single-pole-double throw (SPDT) relay that supplies 24VAC to the latch and heat circuits. The relays on this board are soldered to the board. If a relay fails, the board must be replaced. K1 is a single-pole-double throw (SPDT) relay that supplies voltage through the high limit switch.

The SIB LEDs (labeled LED1 through LED7) are arrayed around the board to assist in troubleshooting.

The chart in section 1.7.3 illustrates current flow through the board, and the table in section 1.7.4 identifies frequently used test points.

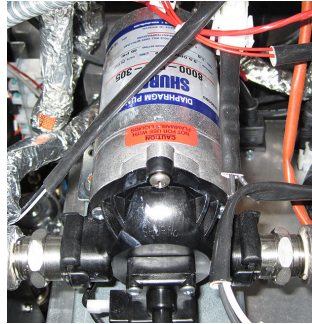
Figure 22

Disconnect the fryer from the electrical power supply. Locate the ATO pump (see Figure 22. Mark and unplug any wires or harnesses. Press down from the top on the quick disconnects to release the plumbing (see Figure 23). The plumbing can be pulled from the pump. Loosen the four nuts attaching the pump to the pump tray. Disconnect the electrical connection. Replace the defective component and reverse above steps. Once replaced, reconnect the power.

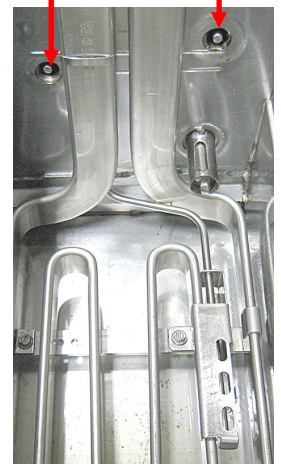
Figure 24

VIB (AIF) Probe ATO Probe

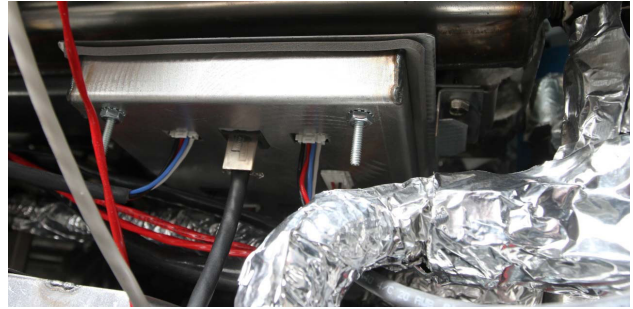
Figure 25

The VIB (Valve Interface Board) controls the actuators that open and close the drain and return valves. The VIB boards are located inside a protective housing under each frypot (see Figure 25).

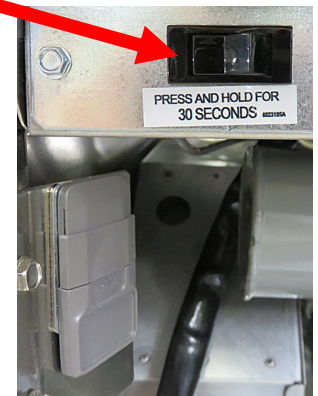
Figure 31

The control power switch is a rocker switch, located on the front of the left control box above the USB port (see Figure 31), that controls all power to all the controllers and boards in the fryer. It is necessary to power cycle all power after replacing any controller or board and after any setup change. Turn off the switch for **sixty (60) seconds** when cycling the control power to ensure power has sufficiently drained from boards.

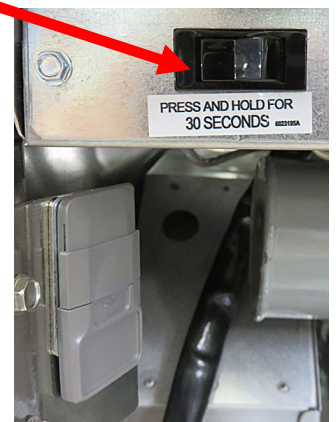
Figure 34

25. Cycle the fryer control power using the switch on the front of the left contactor box (see Figure 34). **ENSURE THE SWITCH IS TURNED OFF FOR 60 SECONDS.**
