Frymaster[®]

FilterQuick[™]

FQG80T/100T/120T easyTouch[®]

Service Manual

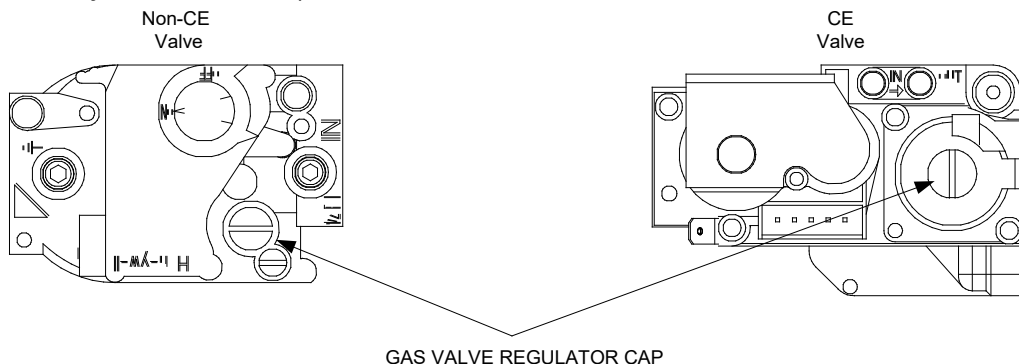
Figure 1B

2. Remove the pressure tap plug from the gas valve assembly (see Figure 1B).
3. Insert the fitting for a gas pressure-measuring device into the pressure tap hole.
4. **On non-CE fryers only**, place the gas valve in the ON position
5. Place the fryer power switch in the ON position. When the burner has lit and burned steadily for at least one minute, compare the gas pressure reading to the pressure for the corresponding gas in the appropriate table on the following page. The tables on the following page list the burner manifold gas pressures for each of the gas types that can be used with this equipment.
6. To adjust the burner gas pressure, remove the cap from the gas valve regulator and adjust to the correct pressure.

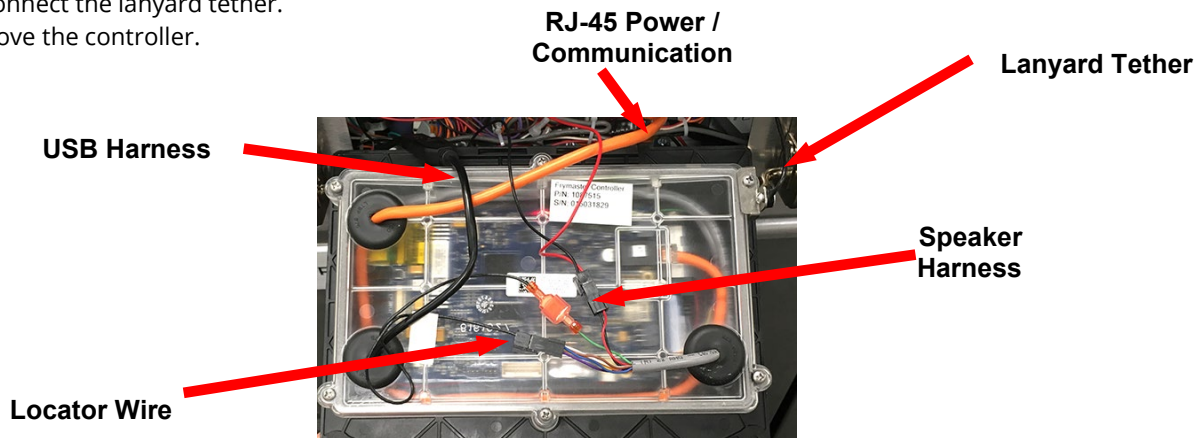
Figure 2

1. **Disconnect the fryer from the electrical power supply. The fuse located at the bottom of the control box can be removed to remove power from individual control boxes.**
2. The controller is held in place by two screws in upper corners.
3. Remove the two screws from the upper corners of the controller.
4. Slide the controller up and it will swing open from the top.
5. Disconnect the RJ45 cable from the SIB board **FIRST (see Figure 2).**
6. Disconnect the other cables from the connectors on the back of the controller marking their position for reassembly.
7. Disconnect the lanyard tether.
8. Remove the controller.

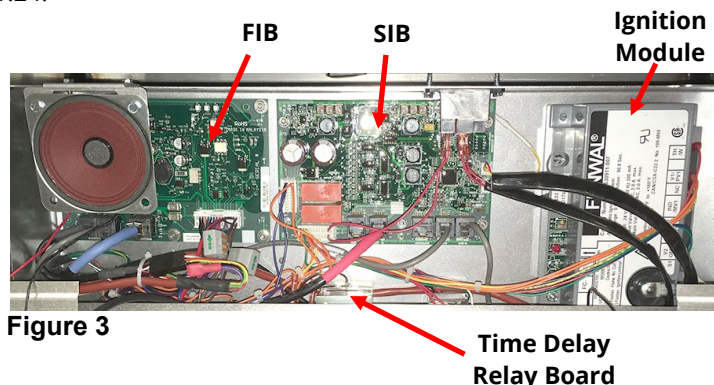
Figure 3

(Smart Interface Board (SIB), the Filtration Interface Board (FIB), Time Delay Relay Board, KCCM (SUI) communication board, or the Ignition Module) (NOTE: All components are not present in each component box.)

1. Perform steps 1 through 8 from section 1.15.1.
2. Remove the bezel by removing the two (2) screws on the bottom of the bezel.

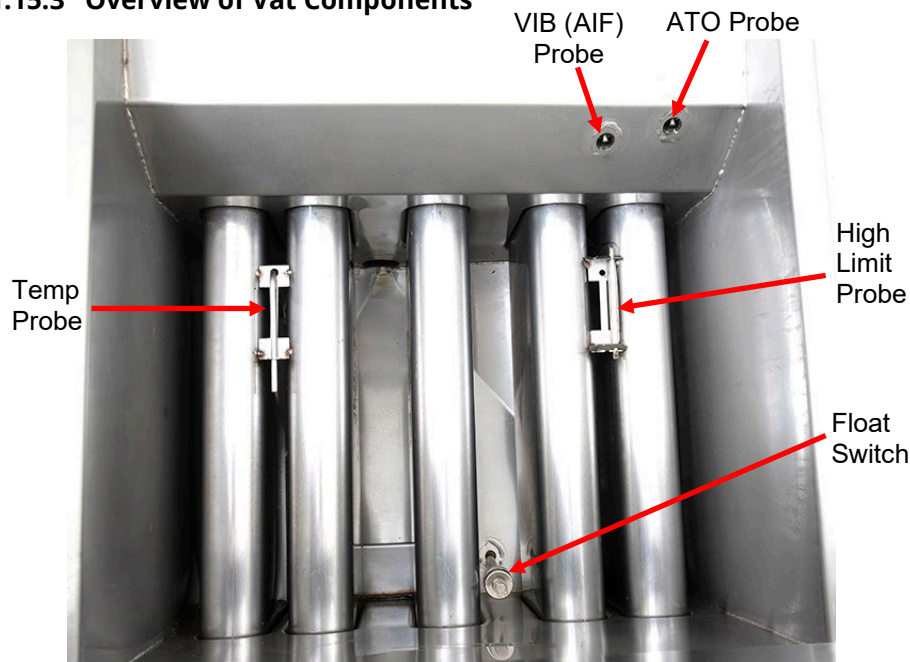
Figure 4

1.15.3 Overview of Vat Components

4. Disconnect the temperature probe (J11) from the SIB board (see Figure 6).
5. Locate the temperature probe to be replaced inside the frypot (see Figure 4).

4. Locate the high-limit probe to be replaced inside the frypot (see Figure 4).
5. Using pliers, carefully bend the outer tab at the rear of the high limit until the high limit can slide back and out of the retaining bracket (see Figure 9).

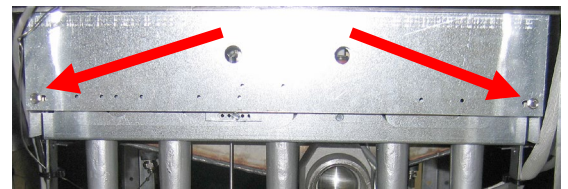
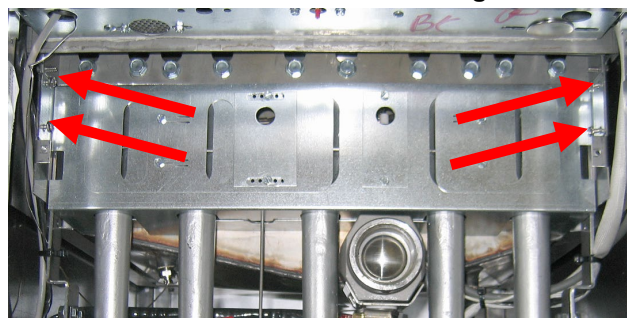
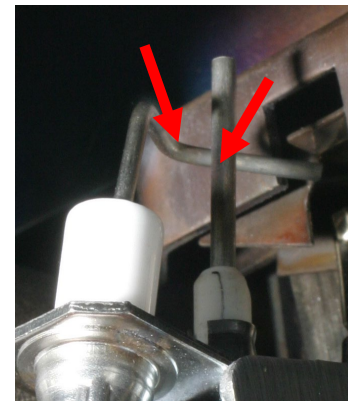
1.15.11 Adjusting the Ignitor Assembly

1. Disconnect the fryer from the electrical supply.
2. Remove the outer cover plate by removing two screws as shown in Figure 30.
3. Remove the air shutter plate if applicable by removing the four screws in the four corners as shown in Figure 31.
4. Gently bend the ignitor spark probe until the gap distance is approximately $\frac{1}{4}$ " inch between the two points as shown in Figure 32.
5. Reverse the steps to reassemble.

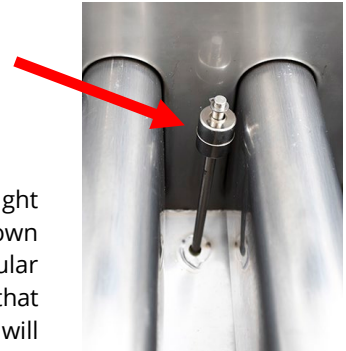
Figure 33

The main indicators of this are that the fryer may light intermittently, fail to light or light with low oil levels. A visual clue is the float switch (see Figure 33) is stuck in the down position with oil over it or stuck in the up position with the oil level below it. Regular cleaning of the float switch prevents this issue. Ensure when removing the float switch that its position is clearly marked and replaced properly. Installing the float upside down will change the switch from N/O to N/C. This could allow the empty frypot to ignite. See float switch troubleshooting in Section 1.22.5.1.

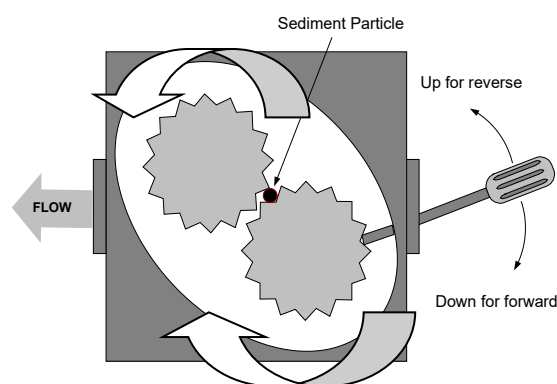
Figure 37
Internal Oil Flow is illustrated by large arrows.

1. Disconnect power to the filter system.
 2. Remove the input plumbing from the pump.
 3. Use a screwdriver to manually turn the gears (see Figure 37).
- Turning the pump gears backwards will release a hard particle and allow its removal.
 - Turning the pump gears forward will push softer objects and solid shortening through the pump and allow free movement of the gears.
4. Prior to reassembly, the inside housing must be clean and free of any sediment or debris. If not, the gears will bind again after reassembly.

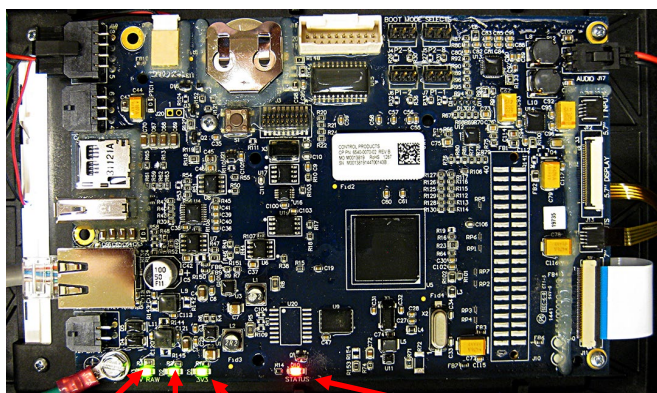
There are four (4) LED status lights on the rear of the controller which provide a quick method to verify power and touch screen functionality on the FQ4000 controller.

To verify that the FQ4000 has power and the touch screen is functional, remove the 2 screws attaching the controller to the bezel. Lower the controller to view the LED's on the rear of the controller board. Verify that the three (3) green LED's are illuminated which indicate that 3V, 5V and 12V power is present on the controller. These should always be illuminated. Pressing anywhere on the front of the touch screen will illuminate the red LED STATUS (see photo below). The red LED will also illuminate momentarily during power up.

12V from SIB
5V from SIB
3V from power supply on UIB
