FilterQuick™ FQGLA-T

Gas Fryer

Service Manual

Part Number: FRY_SM_8197443 03/2022

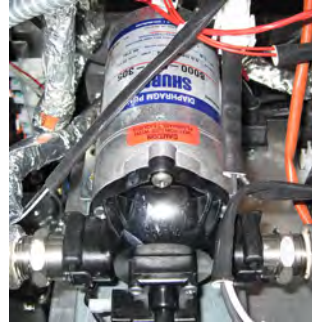
Figure 33

Disconnect the fryer from the electrical power supply. Locate the ATO pump (see Figure 33), behind the ATO box. Mark and unplug any wires or harnesses. Press down from the top on the quick disconnects to release the plumbing (see Figure 34). The plumbing can be pulled from the pump. Loosen the four nuts attaching the pump to the pump tray. Disconnect the electrical connection. Replace the defective component and reverse above steps. Once replaced, reconnect the power.

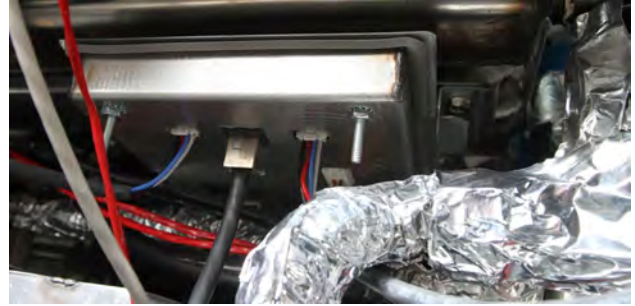
Figure 39

The VIB (Valve Interface Board) controls the actuators that open and close the drain and return valves. The VIB boards are located inside a protective housing under each frypot (see Figure 39).
