Regal® Flushometer

NOTE: Also for use with Regal® XL
(Since mid-2010)

The repair kits and parts listed on this page are designed to service all Sloan diaphragm type flushometers, including those manufactured for low consumption (LC) usage.

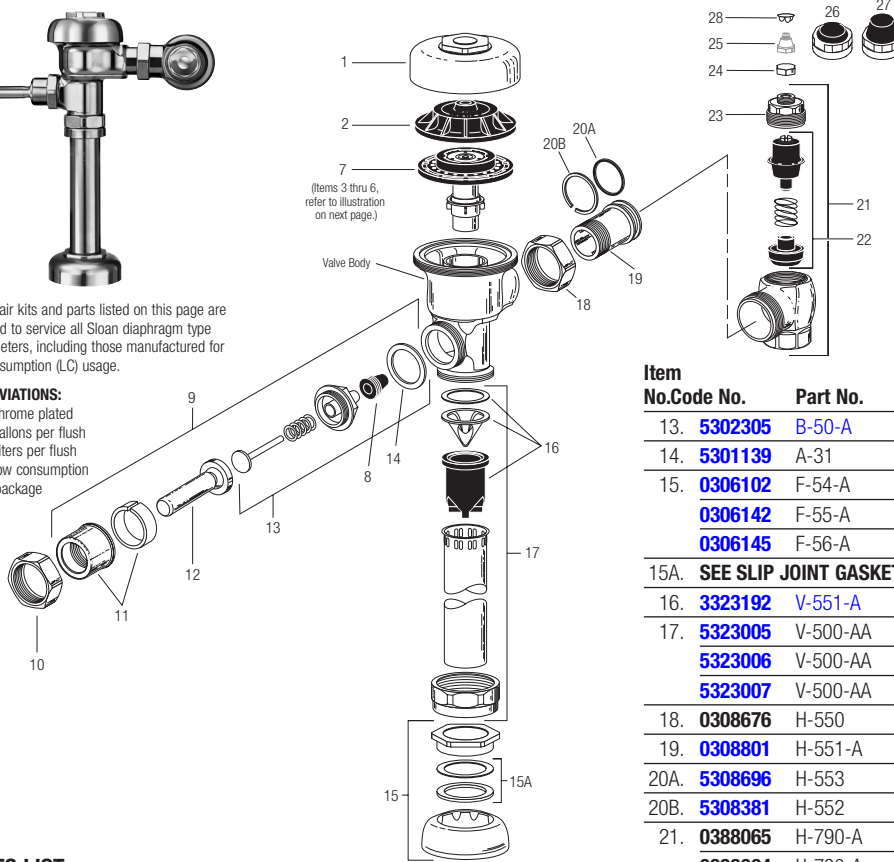
PARTS LIST

Item No.	Code No.	Part No.	Description
1.	0317004	R-10	CP Cover
	—	R-10-HE	CP High Efficiency Cover
2.	0301168	A-71	Inside Cover
SEE ITEMS 3A THROUGH 6E IN CHART ON NEXT PAGE			
3A.	5301058	A-19-AC	Relief Valve, White (Closet) – 12 per package
3B.	5301059	A-19-AU	Relief Valve, Black (Urinal) – 12 per package
3C.	5301211	A-19-ALC	Relief Valve, Green (Closet/Urinal-LC) – 12 per package
3D.	0301143	A-19-AL	Relief Valve, Blue (9 Liter Closet)

4.	5301111	A-15-A	Disc – for all Inside Parts Kits – 12 per package
5.	5301188	A-156-A	Diaphragm – for all Inside Parts Kits – 12 per package
6A.	5301236	A-163-A	Guide Assembly 4.5 gpf/17.0 Lpf Closet & 1.5 gpf/5.7 Lpf Urinal – 12 per package
6B.	5301032	A-152-A	Guide Assembly 3.5 gpf/13.2 Lpf Closet – 12 per package
6C.	5301031	A-151-A	Guide Assembly 1.6 gpf/6.0 Lpf LC Closet – 12 per package
6D.	5301155	A-155-A	Guide Assembly 1.0 gpf/3.8 Lpf LC Urinal – 12 per package
6E.	5301157	A-157-A	Guide Assembly 0.5 gpf/1.9 Lpf Urinal – 12 per package

7.	SEE INSIDE PARTS KITS CHART ON NEXT PAGE		
8.	5302297	B-39	Seal – 12 per package
9.	5302279	B-32-A	CP Handle Assembly – 6 per package
	0302390	B-73-A	CP Handicap Handle Assembly (ADA Compliant)

10.	0301082	A-6	CP Handle Coupling
11.	0302109	B-7-A	CP Socket Assembly
12.	5302274	B-32	CP Handle Grip – 12 per package
	0302389	B-74-A	CP Handicap Handle Grip (ADA Compliant)

Item No.	Code No.	Part No.	Description
13.	5302305	B-50-A	Handle Repair Kit – 6 per package
14.	5301139	A-31	Handle Gasket – 48 per package
15.	0306102	F-54-A	3/4" CP Spud Coupling Assembly
	0306142	F-55-A	1-1/4" CP Spud Coupling Assembly
	0306145	F-56-A	1-1/2" CP Spud Coupling Assembly
15A.	SEE SLIP JOINT GASKETS AND RINGS TABLE BELOW

16.	3323192	V-551-A	Vacuum Breaker Repair Kit
17.	5323005	V-500-AA	3/4" x 9" CP Vacuum Breaker – 6 per package
	5323006	V-500-AA	1-1/4" x 9" CP Vacuum Breaker – 6 per package
	5323007	V-500-AA	1-1/2" x 9" CP Vacuum Breaker – 6 per package

18.	0308676	H-550	CP Stop Coupling†
19.	0308801	H-551-A	CP Adjustable Tailpiece 2-1/16" long†
20A.	5308696	H-553	O-ring – 24 per package
20B.	5308381	H-552	Locking ring – 12 per package

21.	0388065	H-790-A	1" Screwdriver Bak-Chek® Stop CP – complete
	0388064	H-790-A	3/4" Screwdriver Bak-Chek® Stop CP – complete
	0388029	H-740-A	1" Screwdriver Bak-Chek® Stop CP – OBSELETE
	0388031	H-740-A	3/4" Screwdriver Bak-Chek® Stop CP – OBSELETE

22.	3308853	H-541-ASD	1" Control Stop Repair Kit *
	3308856	H-543-ASD	3/4" Control Stop Repair Kit **
23.	0308612	H-622	CP Bonnet (Current Regal)
	0308991	H-639	CP Bonnet – Pre 2010 Regal Stops*
	0308601	H-538	CP Bonnet ** – OBSELETE

24.	5388001	H-1012-A	CP Cap – 6 per package VP
25.	5310034	J-2/J-7	Bumper Assembly – 6 per package – OBSELETE
26.	3308866	H-574	Stop Cap, chrome plated with Seat Bumper (-YO)

27.	3308867	H-576	Stop Cap, chrome plated with Extended Seat Bumper (-YG)
28.	5388002	H-528	Hole Plug
29.	3388015	H-1015	Flow Control Kit (HEU Only) (not Shown)

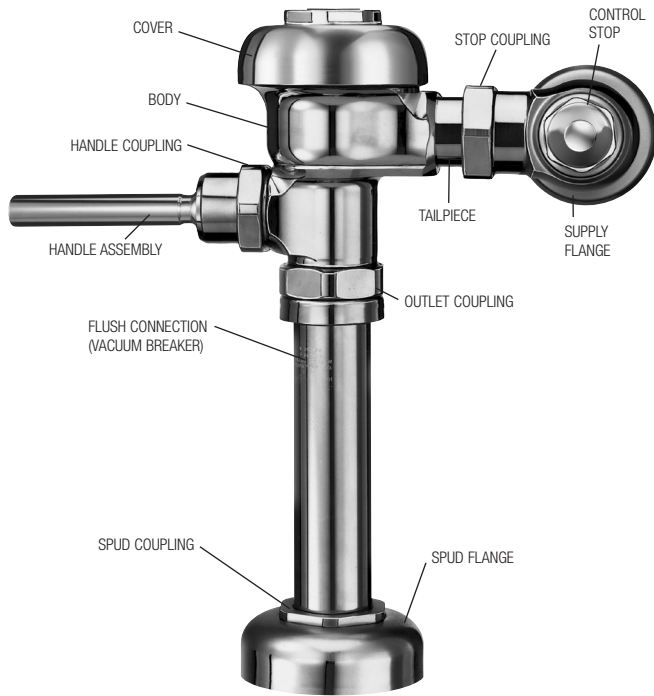
MASTER FLUSHOMETER REBUILDING KITS (SEE PARTS LIST – ON PREVIOUS PAGE)

Refer to Parts List. Includes Items 7, 13, 16 & 20

Code No.	Part No.	Description
3317001	R-1001-A	Rebuild Kit (4.5 gpf/17.0 Lpf) Closet/Service Sink
3317002	R-1002-A	Rebuild Kit (1.5 gpf/5.7 Lpf) Urinal
3317003	R-1003-A	Rebuild Kit (3.5 gpf/13.2 Lpf) Closet
3317004	R-1004-A	Rebuild Kit (1.6 gpf/6.0 Lpf) Closet
3317005	R-1005-A	Rebuild Kit (1.0 gpf/3.8 Lpf) LC Urinal
3317011	R-1011-A	Rebuild Kit (0.5 gpf/1.9 Lpf) Urinal
3317012	R-1012-A	Rebuild Kit (2.4 gpf/9.0 Lpf) Closet

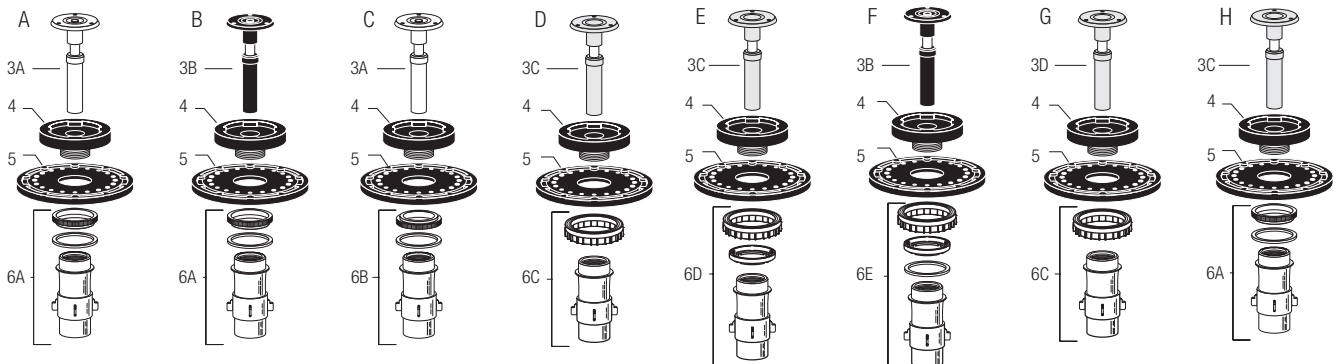
ITEM 7. INSIDE PARTS KITS (SEE ILLUSTRATIONS BELOW)

Item No.	Code No.	Part No.	Application
A.	3301036	A-36-A	4.5 gpf/17.0 Lpf - Closet
B.	3301037	A-37-A	1.5 gpf/5.7 Lpf - Urinal
C.	3301038	A-38-A	3.5 gpf/13.2 Lpf - Closet
D.	3301041	A-41-A	1.6 gpf/6.0 Lpf - Closet
E.	3301044	A-42-A	1.0 gpf/3.8 Lpf - Urinal
F.	3301081	A-43-A	0.5 gpf/1.9 Lpf - Urinal
G.	3301024	A-44-A	2.4 gpf/9.0 Lpf - Closet
H.	3301045	A-140-A	1.28 gpf/4.8 Lpf - Closet

ITEM 7. INSIDE PARTS COMPONENTS (SEE ILLUSTRATIONS BELOW)

Item No.	Code No.	Part No.	Description
3A.	5301058	A-19-AC	Relief Valve, White (Closet) – 12 per pkg.
3B.	5301059	A-19-AU	Relief Valve, Black (Urinal) – 12 per pkg.
3C.	5301211	A-19-ALC	Relief Valve, Green (Closet/Urinal-LC) – 12 per pkg.
3D.	0301143	A-19-AL	Relief Valve, Blue (9 Liter Closet)
4.	5301111	A-15-A	Disc – for all Inside Parts Kits – 12 per pkg.
5.	5301188	A-156-A	Diaphragm – for all Inside Parts Kits – 12 per pkg.
6A.	5301236	A-163-A	Guide Assembly 4.5 gpf/17.0 Lpf Closet & 1.5 gpf/5.7 Lpf Urinal – 12 per package
6B.	5301032	A-152-A	Guide Assembly 3.5 gpf/13.2 Lpf Closet – 12 per package
6C.	5301031	A-151-A	Guide Assembly 1.6 gpf/6.0 Lpf LC Closet – 12 per package
6D.	5301155	A-155-A	Guide Assembly 1.0 gpf/3.8 Lpf LC Urinal – 12 per package
6E.	5301157	A-157-A	Guide Assembly 0.5 gpf/1.9 Lpf Urinal – 12 per package
